3.2 Summary of Inspection Information

3.3 Burner Inspection Conclusions

IGS UNIT #1

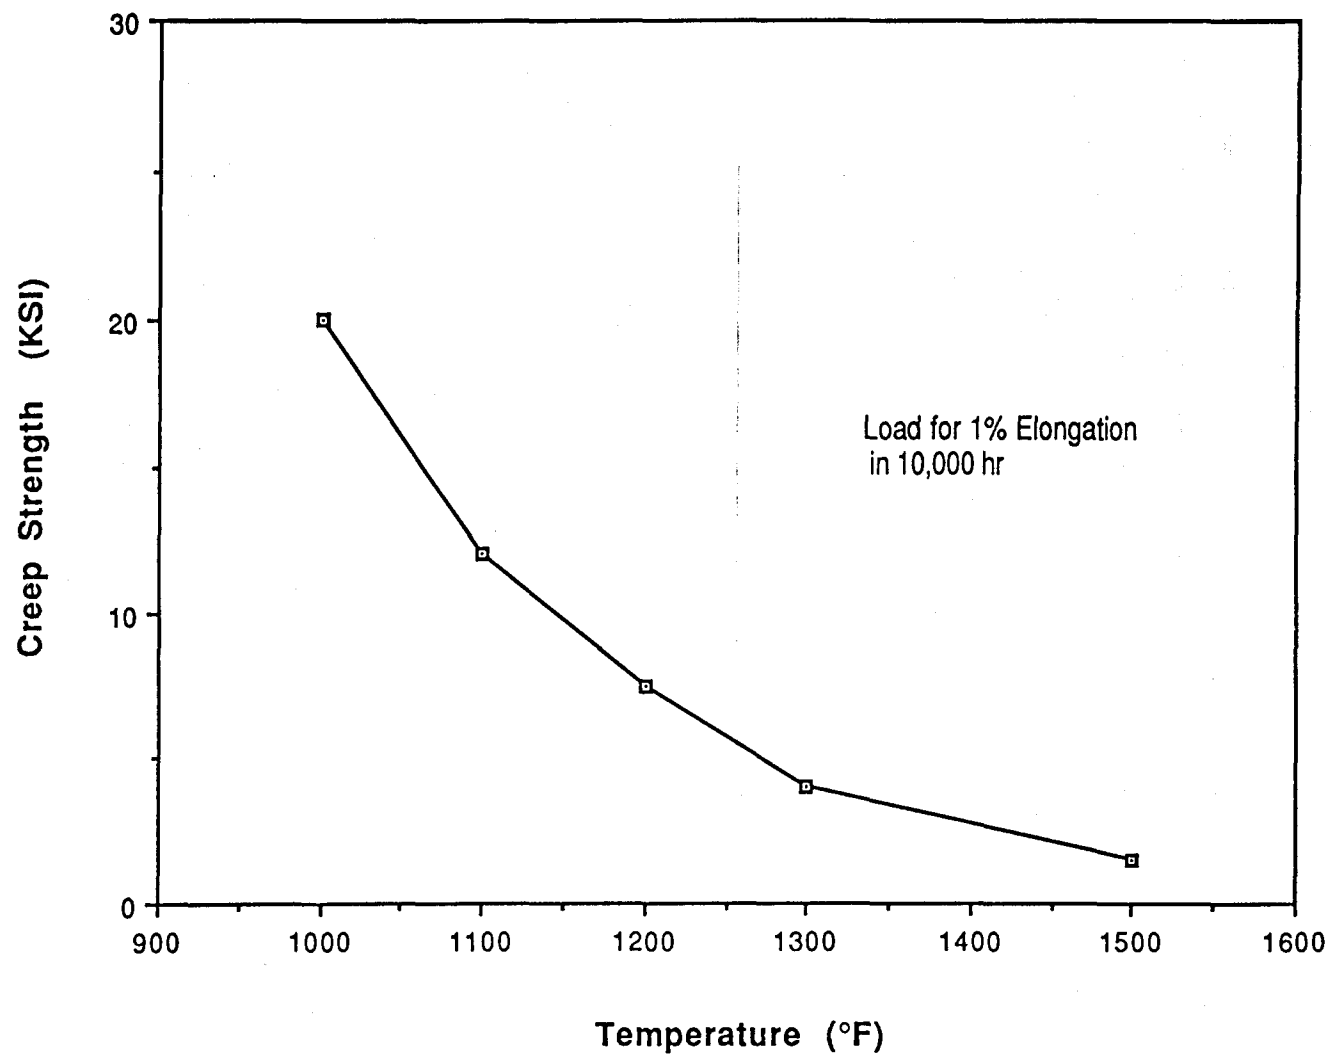
temperature under stress. Depending on the information source, the creep strength of AISI 304 stainless steel is reported as approximately 9.5 KSI at 1150°F and 3 KSI at 1350°F. Figure 3 illustrates the creep strength vs. temperature relationship for 304 stainless steel. For a long term installation such as this burner, the 304 stainless material should be limited to 1150°F.

Creep Strength vs. Temp. for AISI 304 SST

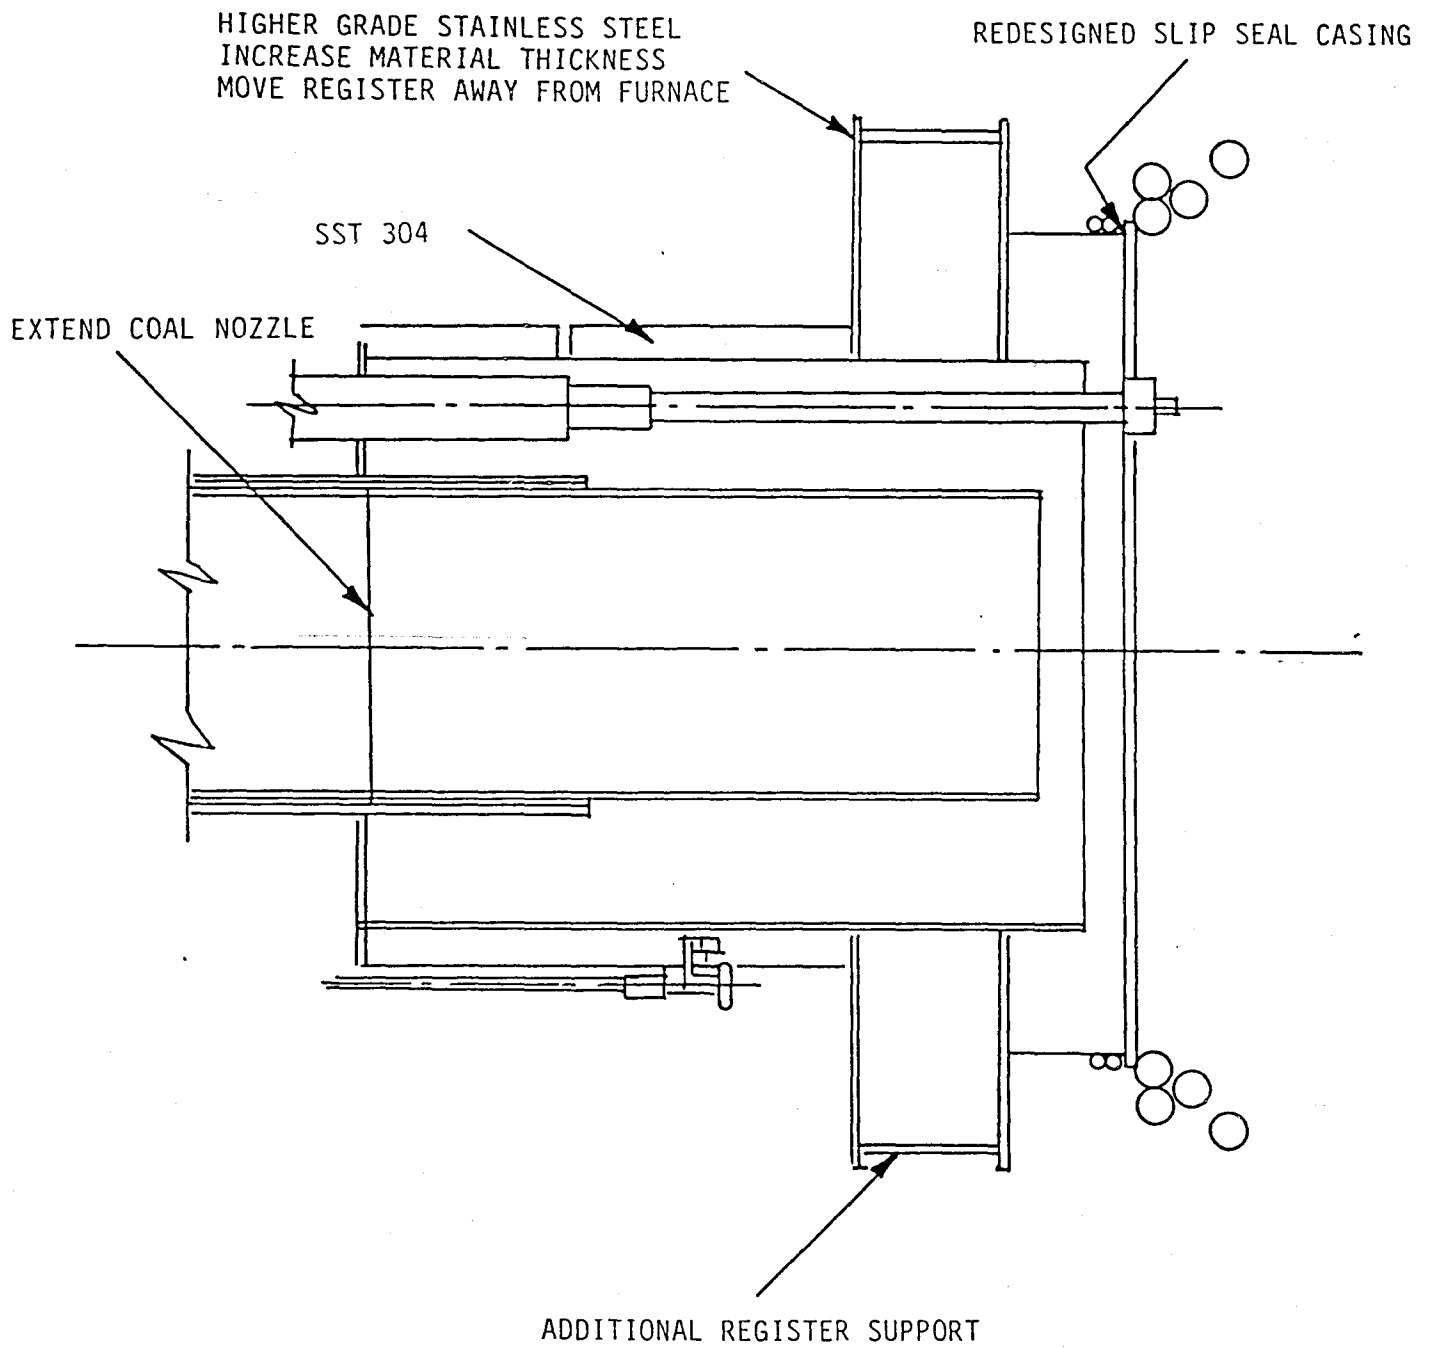
REDESIGNED BURNER
Figure 5

Installing burners that have been redesigned to operate at 1350°F when they are out-of-service is the fourth alternative. The advantages of this alternative are that the boiler efficiency will not be affected and the estimated burner life would be 20-30 years. The burner would remain adjustable which would allow the cooling air flow to be balanced to each of the out-of-service burners. The new burner (see Figure 5) should incorporate the following design changes:

1. The stainless steel material and plate thickness should change on several of the burner components that have failed. This is evidenced by the current HD registers that have been installed in the upper row of burners and have already been permanently warped. A higher grade of stainless steel such as AISI 309 or 310 with a low carbon content would be better suited for high temperatures and welded constructions than a 304 material. This material would provide a higher creep strength and also alleviate long term effects of weld decay (Appendix C). Material thickness would probably also need to be increased on current 309 components to overcome the high stresses that are occurring.

2. The outer register should use the HD register linkage design. This will increase the ability of the register to remain adjustable. Placing the outer register farther back from the furnace should also be considered. This would reduce the amount of heat transfer by radiation and assist in lowering the temperatures of the register back plate and doors. The disadvantage could be the reduction of swirl that is imparted to the secondary air. Considering that the existing burners have good stability while operating with low pressure drop across the burner and severely trimmed register doors, high swirl is evidently not required with the current fuel.

3. The slip seal casing should be redesigned to allow for larger thermal expansions.
4. The reinforcing bars that are welded to the outside of the inner air sleeve should be SST 304 instead of carbon steel.

5. Extension of the alloy tip on the coal nozzle would be necessary because the temperature at the carbon steel junction should be limited to 850°F. The alloy tip should be 48 inches long.

6. Both outer register plates should be supported with register support brackets. Round edges and adequate clearance should be provided on the register support bracket retainer to assure that the register assembly can expand as needed.
